MICROSCOPIC EXAMINATION OF STEEL

HENRY FAY, Ph. D., D. Sc.

*Professor of Analytical Chemistry, Massachusetts Institute of Technology
Consulting Metallurgist, Watertown Arsenal*

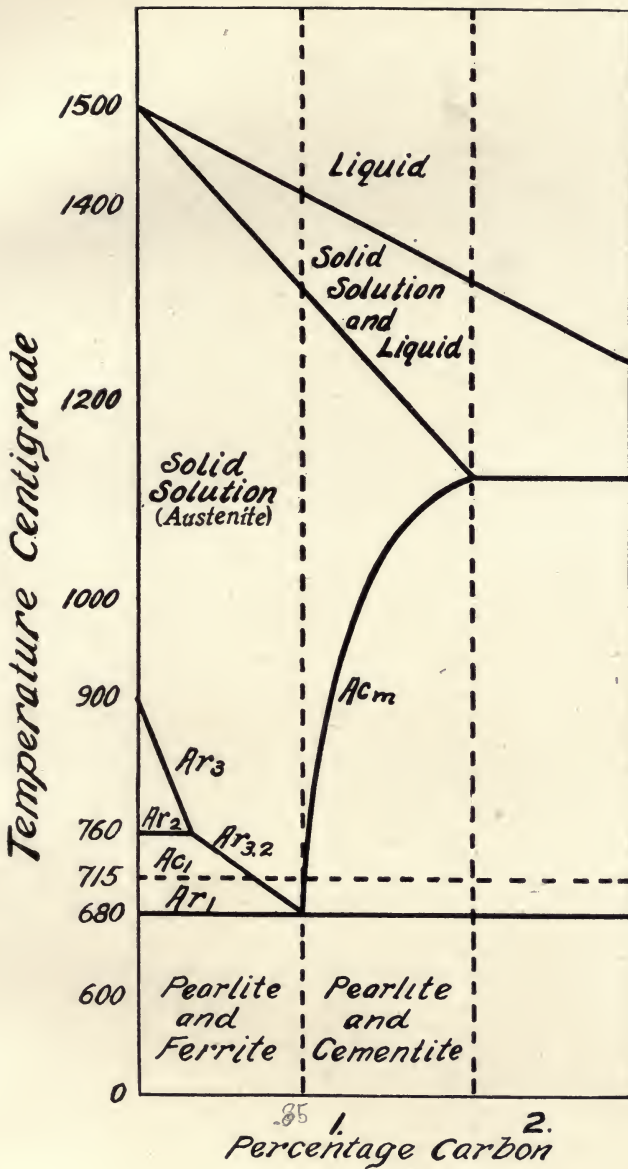
Fig. 1

Portion of iron-carbon diagram

constituents, iron and iron carbide. The A_{c1} point is approximately 30° higher than the A_{r1} point, and represents the beginning of the formation of solid solution. In steels containing 0.85 per cent carbon there is but one critical temperature at which the solid solution decomposes into its constituents, iron and iron carbide. This is known as an eutectoid steel, and its microscopic constituent is pearlite. Pearlite always etches dark, and under high magnifications is shown to consist of alternate laminations of iron and iron carbide. Steels containing less than 0.85 per cent carbon are hypoeutectoid, and contain the microscopic constituents ferrite and pearlite, the amount of the latter increasing with the per cent of carbon. Steels containing more than 0.85 per cent carbon are hypereutectoid, and contain the microscopic constituents cementite (iron carbide, Fe_3C) and pearlite. These facts are illustrated in the diagram. (Fig. 1.)

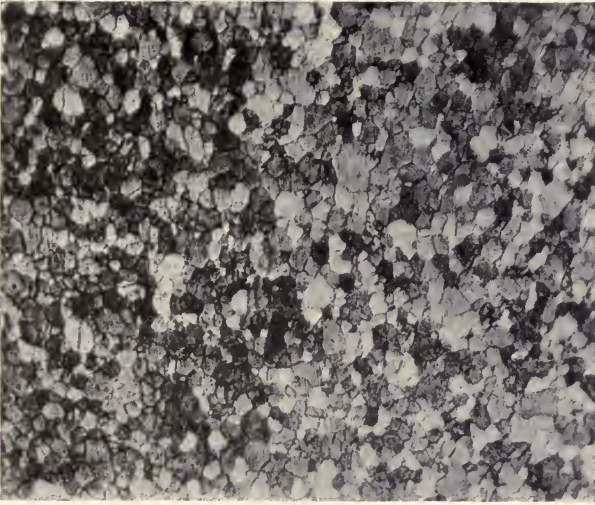
PHOTOGRAPH NO. 1. X75.

0.06% carbon. Approximately pure ferrite.

Photograph No. 1 shows the characteristics of a carbonless iron in which the whole field is made up of granules of ferrite. With the introduction of carbon there is a decrease in the amount of ferrite and the constituent pearlite begins to appear. This is shown in photograph No. 2 for a steel containing 0.18 per cent carbon. Inasmuch as steels containing 0.85 per cent carbon contain 100 per cent pearlite, and as pearlite is composed of ferrite and cementite, in this steel containing 0.18 per cent carbon there ought to be approximately 20 per cent of the field made up of pearlite. In a steel containing 0.5 per cent carbon there should be 58.8 per cent pearlite. Such a steel is shown in photograph No. 4. A eutectoid steel containing 0.83 per cent carbon and practically 100 per cent pearlite is shown in photograph No. 7. Under higher magnifications pearlite shows the laminated structure shown in photograph No. 8. In hypereutectoid steels the excess carbon beyond that necessary to form pearlite, separates as free cementite and the amount of free cementite can be calculated. Inasmuch as the whole field is made up of pearlite

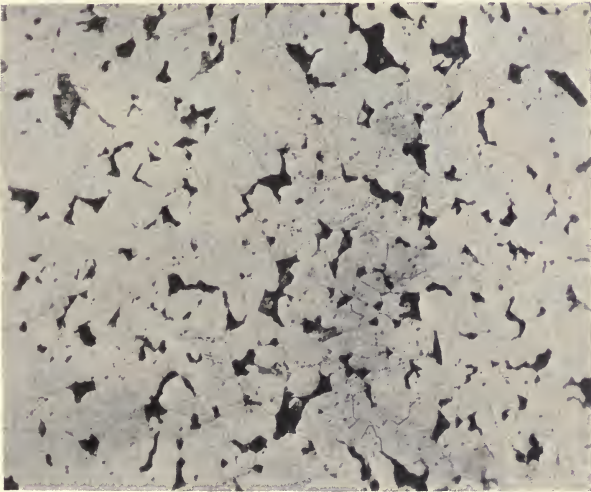
PHOTOGRAPH NO. 2. X75.

0.18% carbon. Ferrite (white) and pearlite (dark).

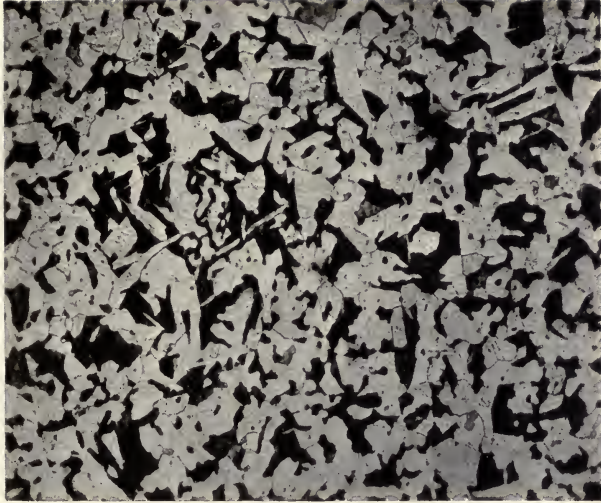
PHOTOGRAPH NO. 3. X75.

0.32% carbon. Ferrite (white) and pearlite (dark).

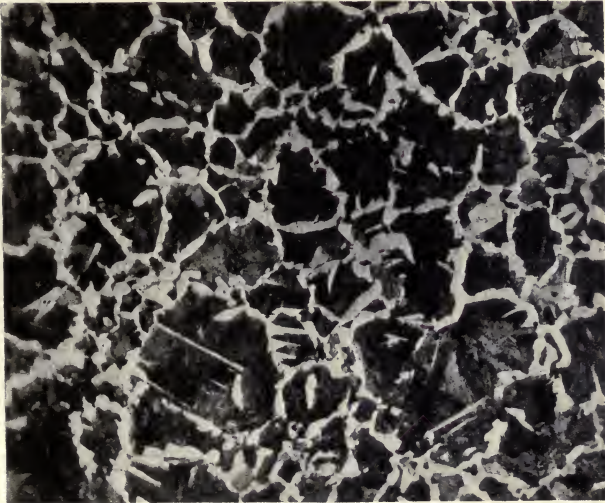
PHOTOGRAPH NO. 4. X75.

0.49% carbon. Ferrite (white) and pearlite (dark).

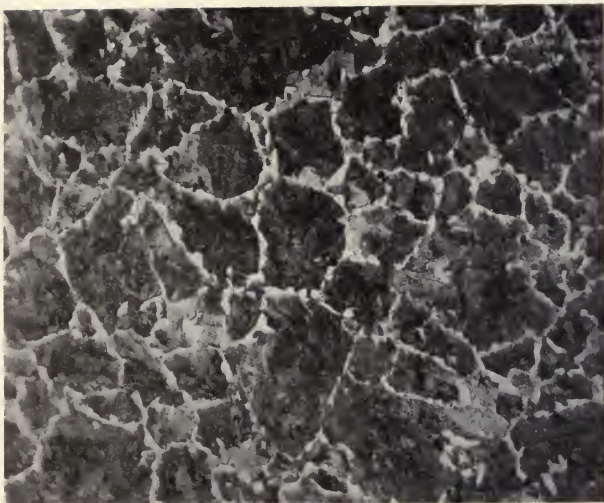
PHOTOGRAPH NO. 5. X75.
0.57% carbon. Ferrite and pearlite.

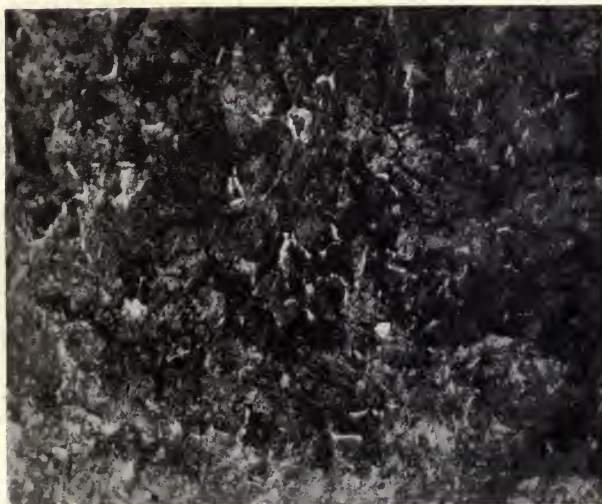
PHOTOGRAPH NO. 6. X75.
0.71% carbon. Ferrite and pearlite.

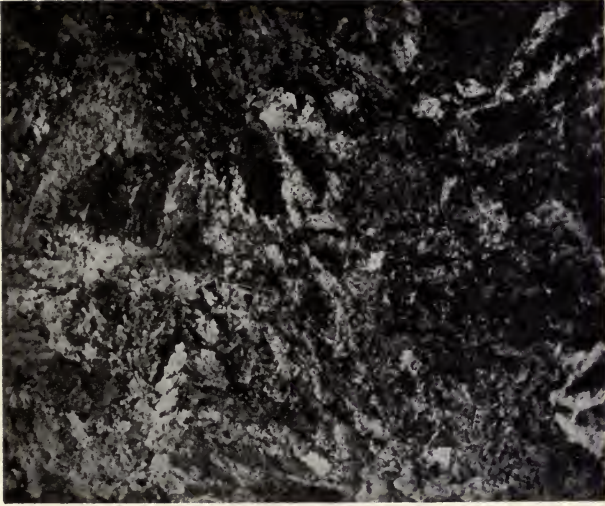
PHOTOGRAPH NO. 7. X75.

0.83% carbon. Pearlite.

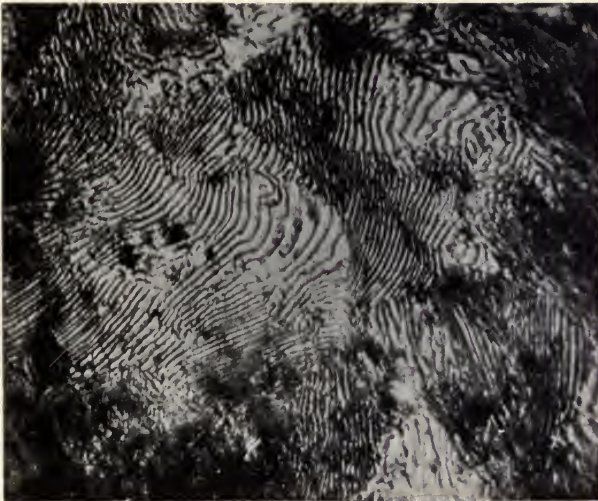
PHOTOGRAPH NO. 8. X485.

0.83% carbon. Pearlite.

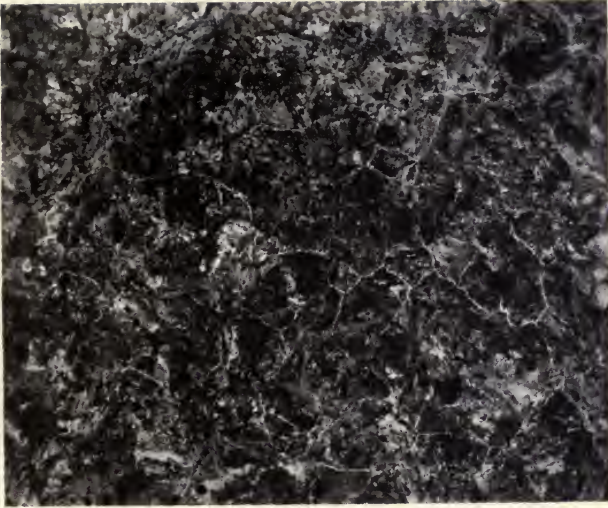
PHOTOGRAPH NO. 9. X75.
1.22% carbon. Pearlite and cementite (white).

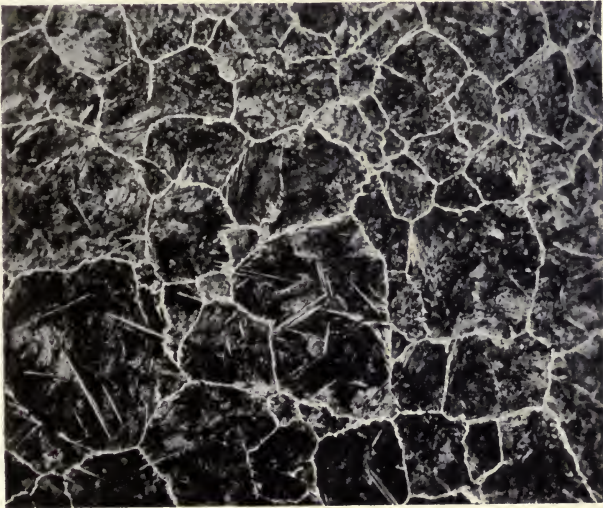
PHOTOGRAPH NO. 10. X75.
1.46% carbon. Pearlite and cementite (white).

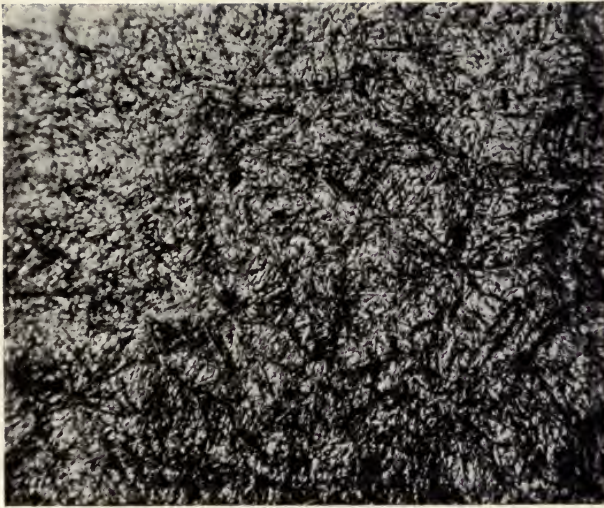
PHOTOGRAPH NO. II. X75.
Martensite.

Photograph No. 11 shows the characteristic appearance. Commercially martensitic steels are unimportant on account of their extreme brittleness and they are found only rarely.

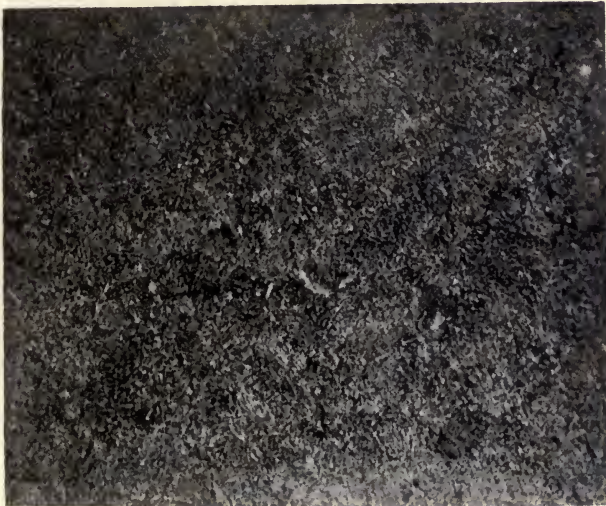
PHOTOGRAPH NO. 12. X75.
Troostite.

If heated to temperatures below A_{c1} , the effect produced will vary with the temperature. The lower the temperature of reheating the smaller is the tendency toward stable equilibrium; the higher the temperature the more stable is the product produced. Practically any degree of hardness may be produced, varying from glass-hard to extreme softness, by properly regulating the temperature of the heating. There are then two extremes, the martensitic steels formed by quenching from above A_{c1} and the pearlitic steels formed by cooling slowly from A_{r1} or above. Intermediate between these extremes are steels in which more or less of the unstable solid solution has been partly converted to more stable forms. Such forms are represented microscopically by troostite and sorbite. Troostite, formed by tempering at relatively low temperatures, represents the first stage in the breaking down of the unstable equilibrium and is characterized by the amorphous or slightly granular structure. On etching with alcoholic nitric acid the surface usually blackens immediately from separated carbon. Photograph No. 12 shows troostite.

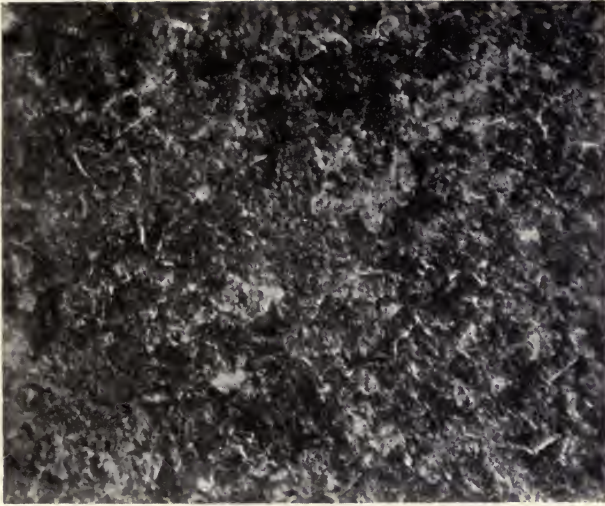
PHOTOGRAPH NO. 13. X75.

Sorbite.

Sorbitic steels are those which have been quenched and heated to a higher temperature and thus represent a more stable state of equilibrium. They are characterized by having a peculiar grayish color, and the structure is better defined than troostite. The particles of iron carbide have not assumed definite laminations with ferrite as in pearlite, but are very much more distinct than in troostite. Photograph No. 13 shows sorbite.

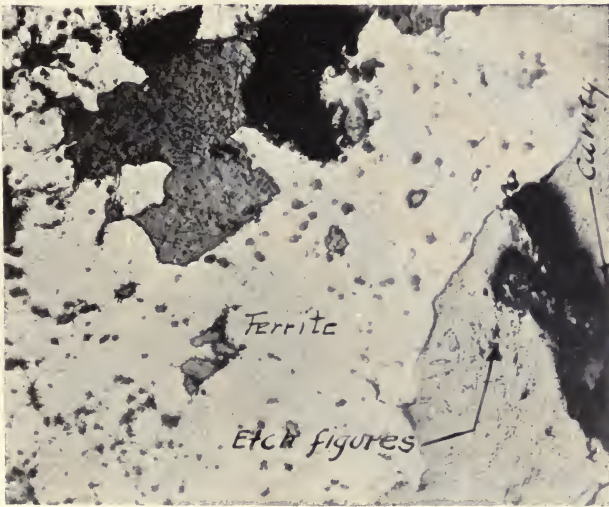
PHOTOGRAPH NO. 14. X50.

Ferrite and massive silicate of manganese. Etch figures in the silicate. (Ferrite, white; silicate, dark.)

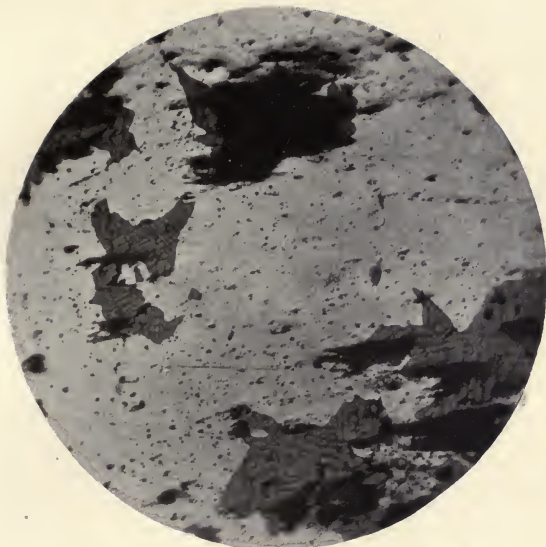
PHOTOGRAPH NO. 15. X50.

Etch figures in silicate of manganese, and cavities due to removal of silicate.

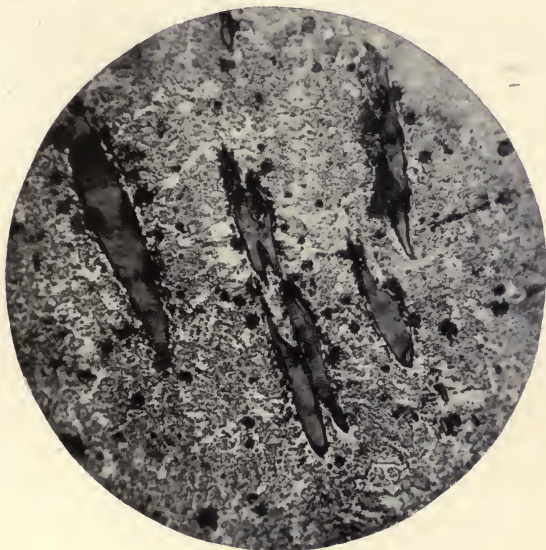
PHOTOGRAPH NO. 16. X50.

Sulphide of manganese in gun steel.

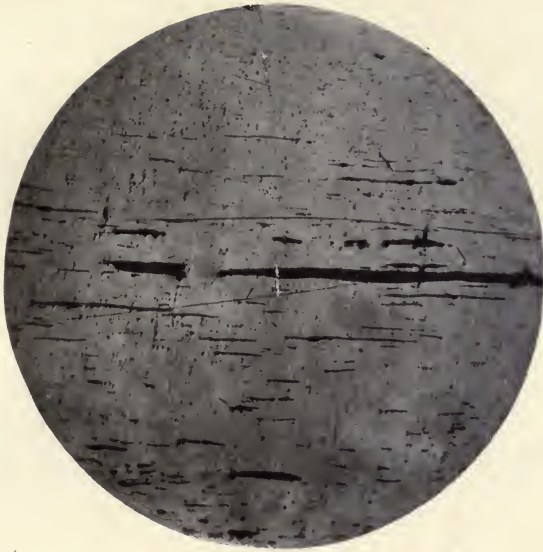
PHOTOGRAPH NO. 17. X50.

Slag elongated in direction of forging. Specimen unetched.

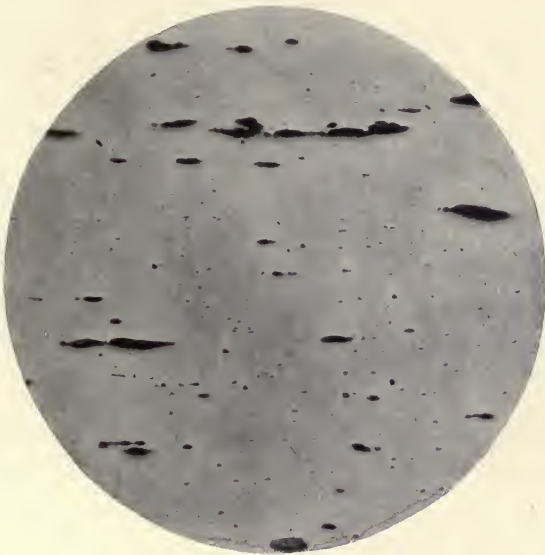
PHOTOGRAPH NO. 18. X50.

Unevenly distributed slag. Specimen unetched.

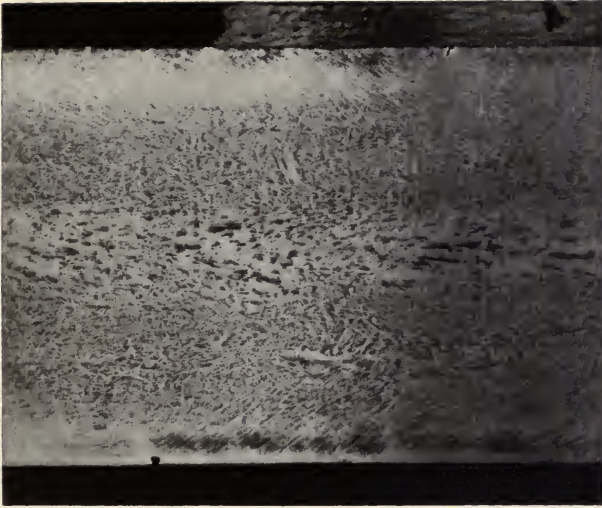
PHOTOGRAPH NO. 19. ONE-THIRD SIZE.
Ingot structure in steel.

The presence of ingot structure such as shown in photograph No. 19 indicates that the heat treatment and forging have not been sufficient to wipe out the crystallization which occurred on the solidification of the metal. It is not definitely known that the presence of ingot structure is harmful, and it is frequently accompanied by excellent microstructure, but it serves as an indication of the heat treatment to which the metal has been subjected after solidification. It is believed that such a structure would not be found in the best steel, and it is further believed that metal showing ingot structure would be more liable to rupture from shock than metal in which the ingot structure had been wiped out by heat treatment and forging.

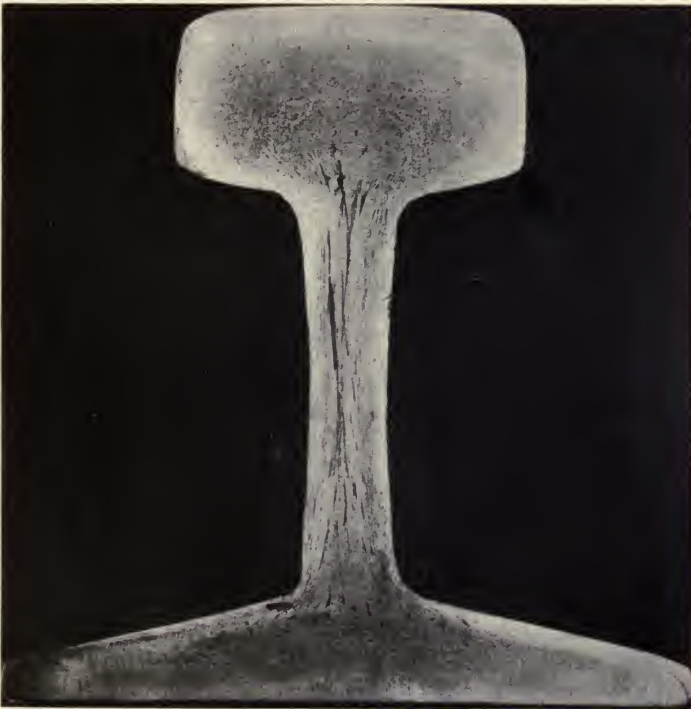
PHOTOGRAPH NO. 20.
Cross section of steel rail showing segregation in center of head, web, and base.

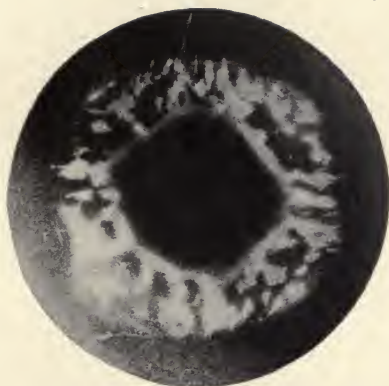
PHOTOGRAPH NO. 21.

**Segregation of phosphorus in cold-rolled shafting.
Etched with iodine. (White areas.)**

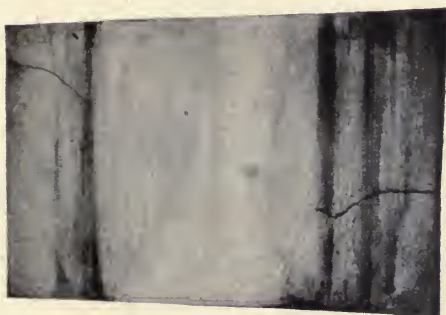
PHOTOGRAPH NO. 22.

**Cross section of No. 21. Etched with nitric acid.
(Dark streaks.)**

in which segregation of phosphorus is shown. Photograph No. 22 shows a longitudinal section of the same piece of shafting and is etched with nitric acid, which darkens the phosphide areas. It is seldom possible, however, to obtain complete cross sections, but valuable indications may be obtained from surface structures or from test-bar sections, such as shown in photograph No. 38 of test bars marked 2, 3, and 5. The phenomena observed here will be more fully discussed later.

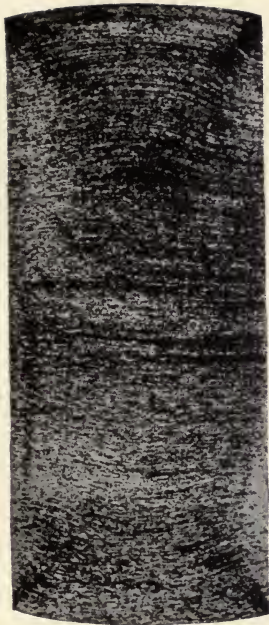
PHOTOGRAPH NO. 23.

Area of strained metal brought out by etching with copper ammonium chloride.

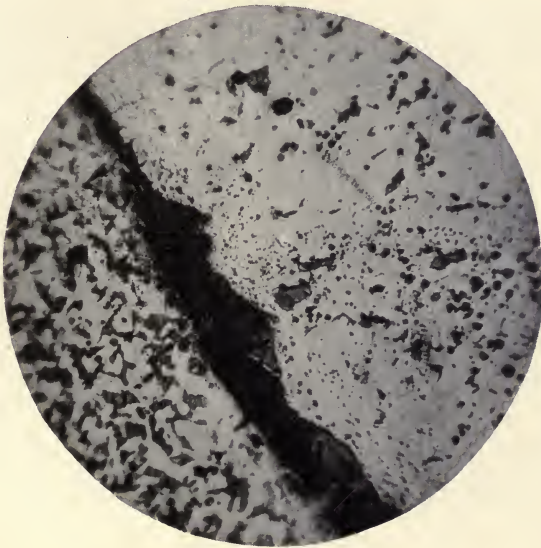
PHOTOGRAPH NO. 24. X50.

Crack, slag, and decarbonized area found on the base of a steel rail.

The inclusion of oxide is frequently accompanied by partial decarbonization, and is most frequently found on or near the surface. An example of this is shown in photograph No. 24, in which it is seen that a crack has penetrated through the slag, probably mill scale, and in the crack are the remnants of the slag. On the left of the crack is the normal structure and on the right is a decarbonized area containing slag. Such an area would probably be large enough to show to the naked eye and would be considered unsafe. Other examples of oxide inclosures are cited on pages 14 and 15, in the discussion of the failure of 10-inch gun and 14-inch gun lever.

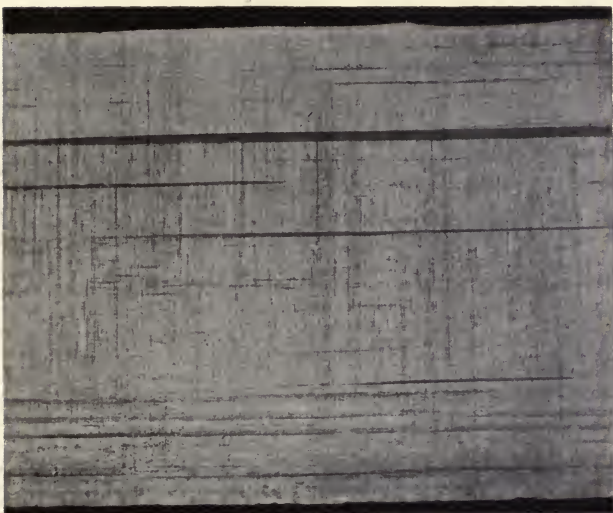
PHOTOGRAPH NO. 25.
Dark streaks in steel rail.

Radial test pieces from gun forgings will frequently show streaks, and as the tension is normal to the direction of extension the specimen will show low ductility. Photographs Nos. 25 and 26 show, respectively, dark and light streaks, and photograph No. 27 shows the microstructure of a portion of the light-colored streak with its decarbonization and accompanying slag. (See also Tests of Metals for 1909, vol. 11.)

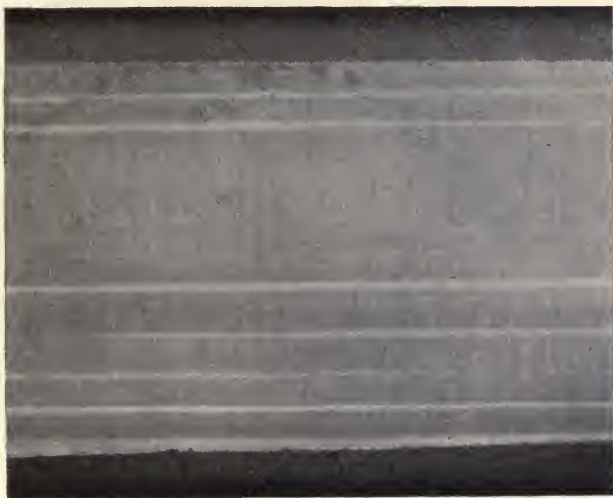
PHOTOGRAPH NO. 26.
Light streaks in steel rail.

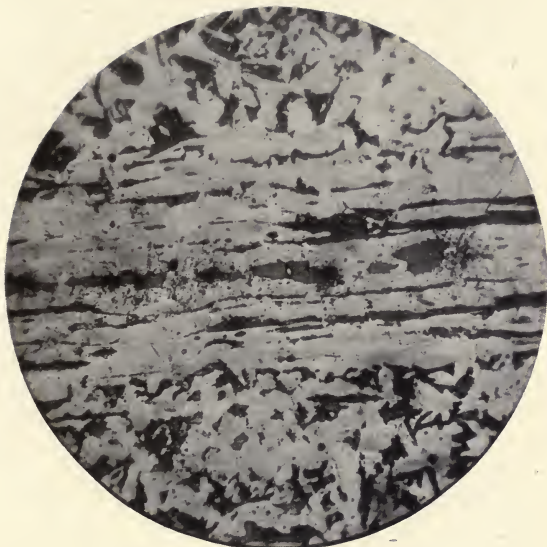
PHOTOGRAPH NO. 27. X50.

Microstructure of light-colored streak in No. 26.

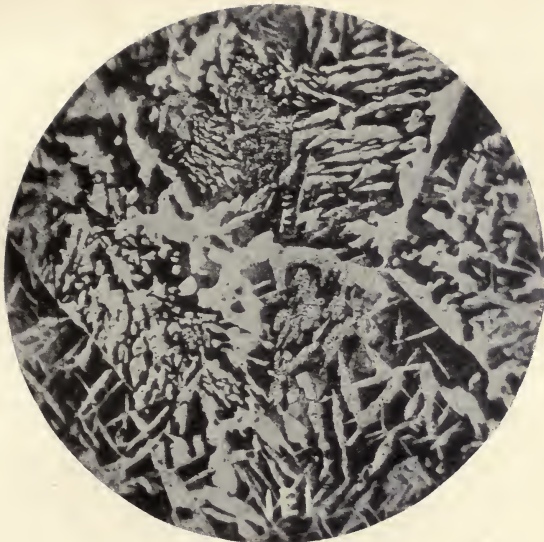
PHOTOGRAPH NO. 28. X75.

Microstructure of cast steel ingot as cast.

Elastic Limit	39,000
Tensile Strength	77,000
Elongation	10.5
Contraction of Area	16.9

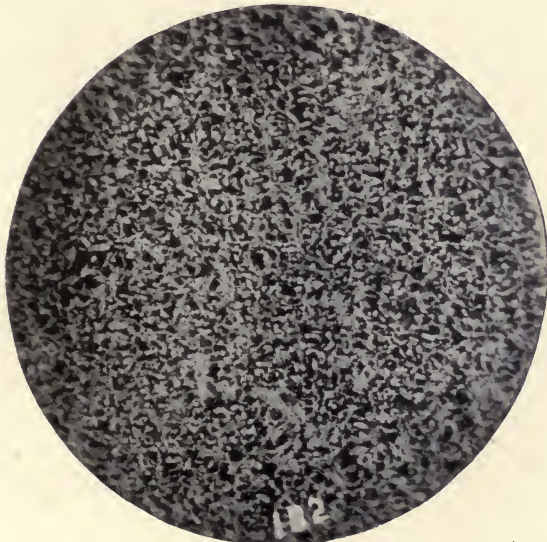
PHOTOGRAPH NO. 29. X75.

Microstructure of cast steel ingot forged to 1450° F. (788° C.)

Elastic Limit	50,500
Tensile Strength	83,500
Elongation	27.5
Contraction of Area	43.3

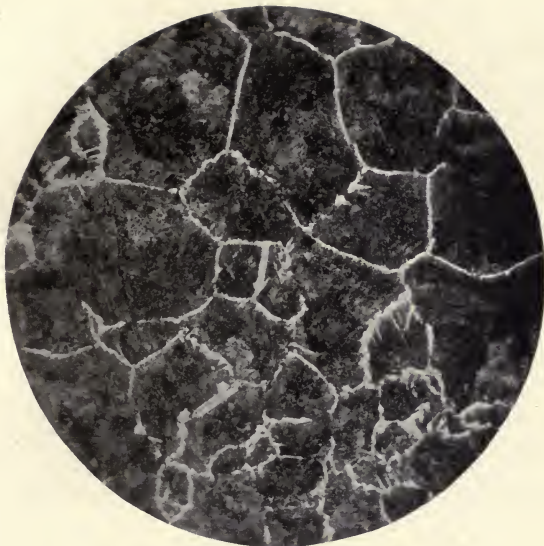
PHOTOGRAPH NO. 30. X75.
Coarse microstructure in gun steel.

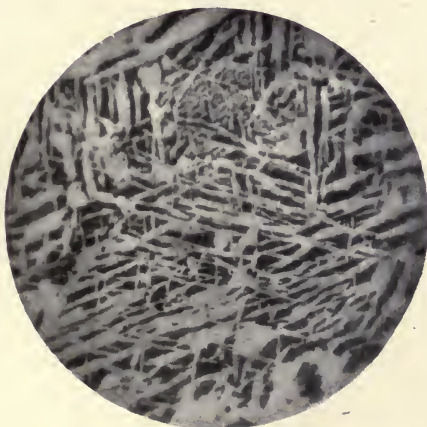
PHOTOGRAPH NO. 31. X50.
Crystalline structure in cast steel.

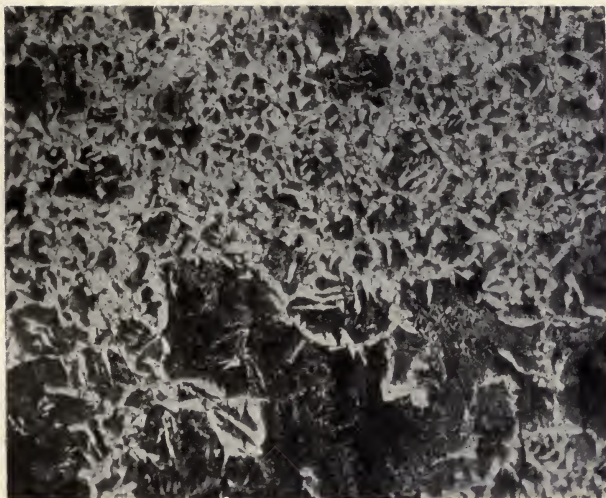
PHOTOGRAPH NO. 32. X75.

Microstructure showing incomplete heat treatment.

Failure to obtain uniformity of structure is shown in photograph No. 32. Discussion of photographs Nos. 49, 51, and 53 will be found under the discussion of some of the special cases, viz., the failure of 14-inch gun lever arm. Dangerous overheating is shown in photograph No. 33. In this case the material is burnt, as is shown by the oxide between the granules of pearlite.

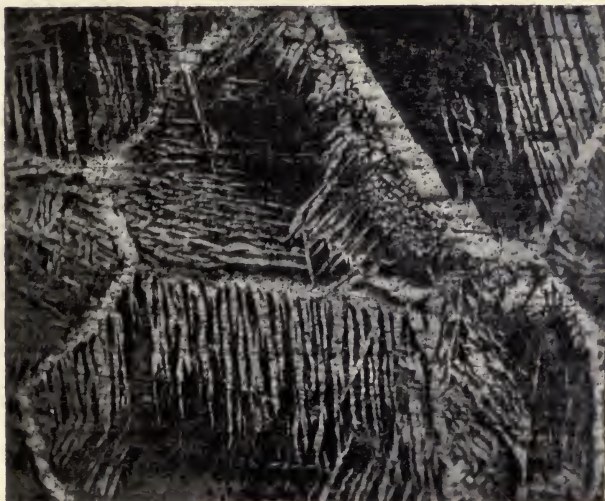
PHOTOGRAPH NO. 33. X75.

Microstructure of overheated steel.

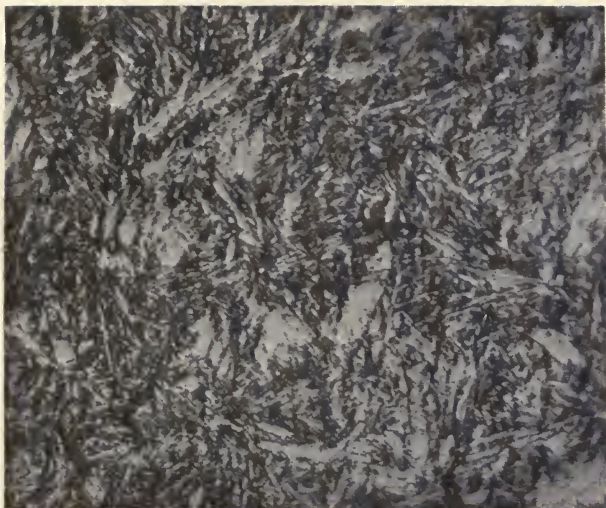
PHOTOGRAPH NO. 34. X500.

Microstructure of forging which had been originally martensitic, and in tempering this structure has not been completely eliminated.

observed that the original martensitic structure is completely removed by the tempering process. This point is illustrated by photograph No. 34 in which there are distinct remains of the original martensitic structure. Such a steel properly heat treated ought to show a structure similar to photographs Nos. 12 or 13.

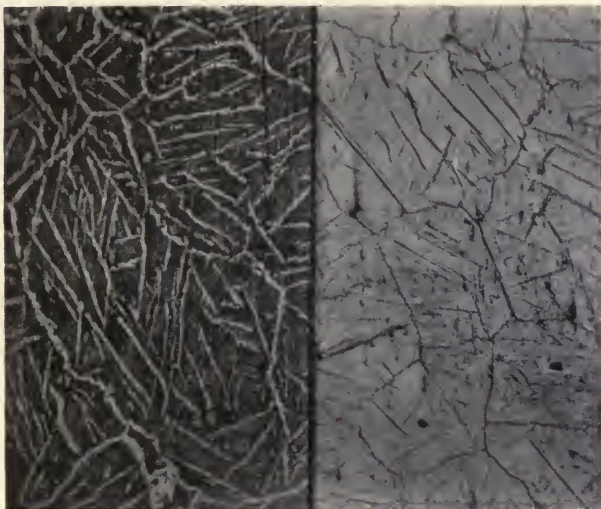
PHOTOGRAPH NO. 35. X65.

Microstructure in center of broken recoil spring showing excess cementite, indicating high carbon. Left, white lines are cementite etched with nitric acid solution; right, dark lines are cementite etched with sodium picrate solution.

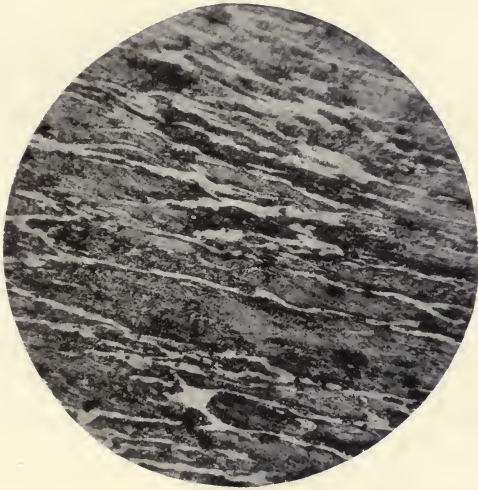
PHOTOGRAPH NO. 36. X50.

**Microstructure of steel subjected to cold work, and
showing distortion of grain.**

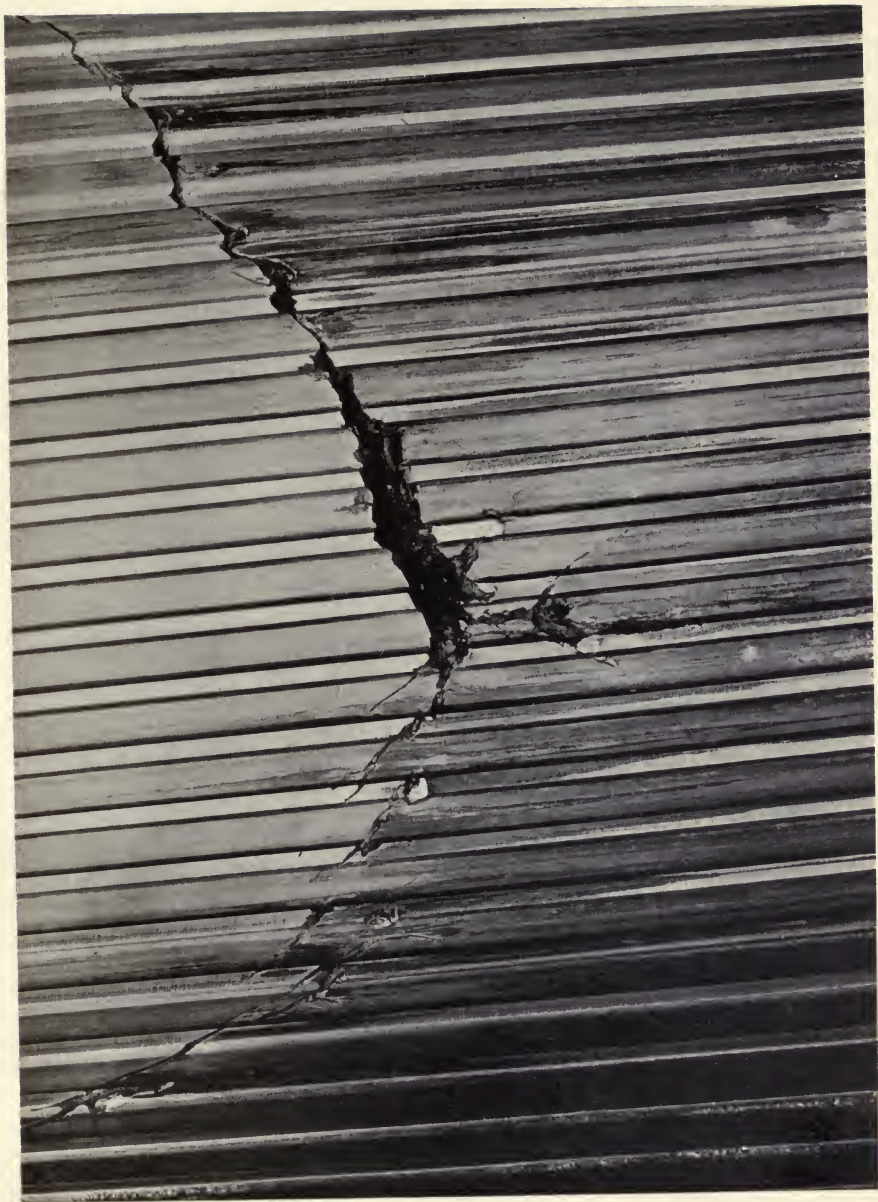
PHOTOGRAPH NO. 37.
Crack in 10-inch rifle.

The tube of this gun was found to be cracked after proof-firing. The crack was situated about 2 feet in from the breech end and extended in the form of a crescent through a visible distance of about 10 inches. At the central portion of the crack the walls were considerably more separated than at either end, and considerable metal had been removed at this point. The general appearance is shown in photograph No. 37. It will be noted that the crack is not continuous.

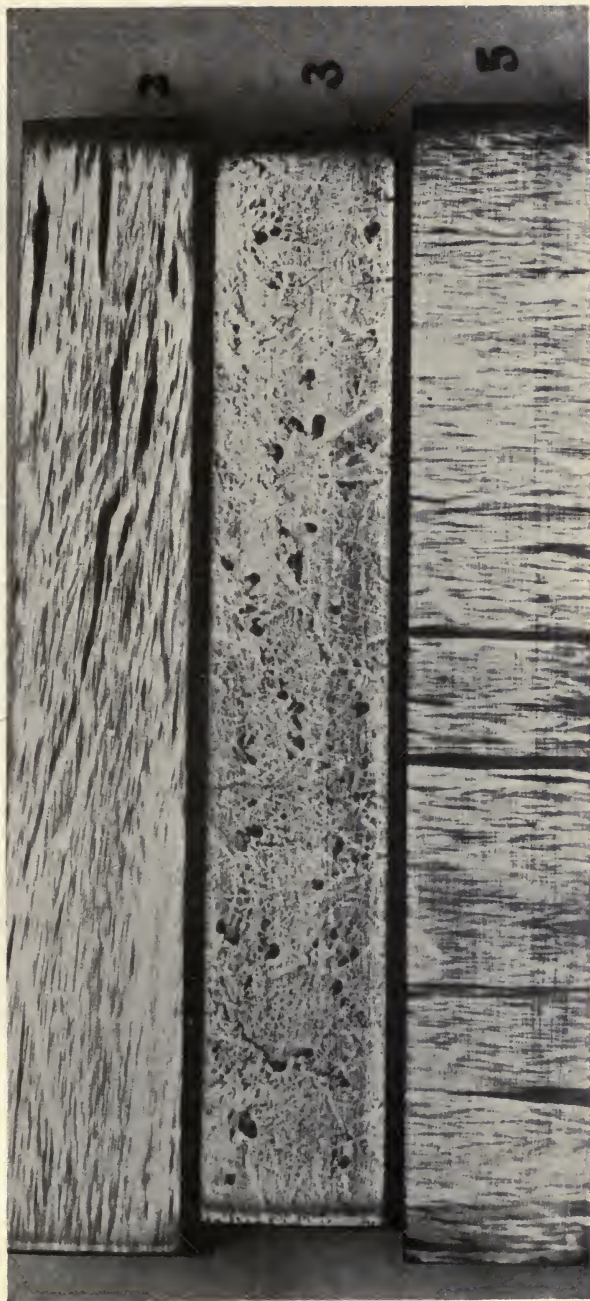
PHOTOGRAPH NO. 38.

Macrostructure of test bars of 10-inch rifle, showing surfaces cut longitudinal (5), radial (3), and tangential (2) to axis.

Photographs Nos. 38 and 39 show the macrostructure of this steel when etched with iodine, the specimens shown in photograph No. 38 being taken longitudinally, radially, and tangentially. The segregation of phosphorus is indicated by the dark lines in pieces Nos. 2 and 5 of photograph No. 38 and in both pieces of photograph No. 39 and by the dark spots in piece No. 3. Photograph No. 39 shows the metal cut from the region of the fracture and treated in the same manner, as shown in test piece marked 5 in photograph No. 38, and in other test pieces not shown. The dark streaks were found to be elongated parallel to the direction of forging, and it is reasonable to suppose that the elongation will always be parallel to the surfaces being forged. By inspection of the two larger pieces of metal cut from the region of the crack (photograph No. 39) it will be seen that there is considerable distortion of the phosphide areas near the

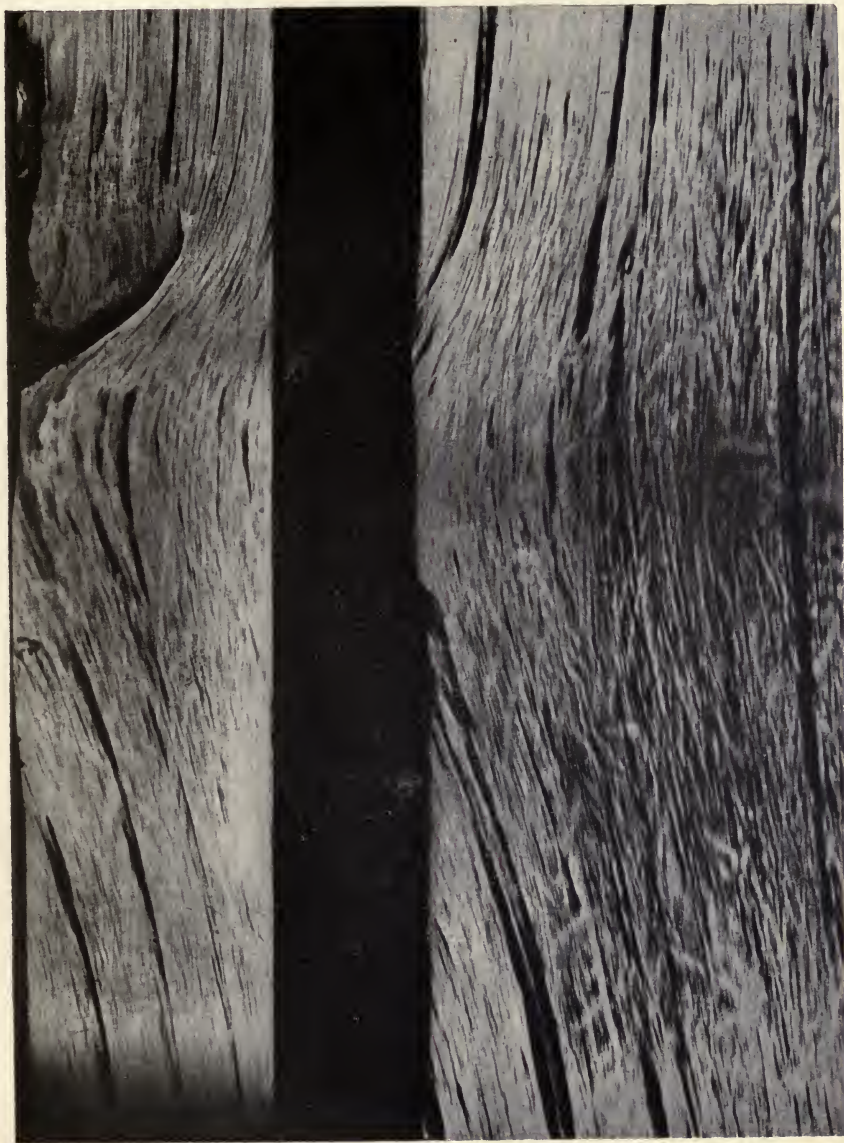
PHOTOGRAPH NO. 39.

Macrostructure in region of crack in 10-inch rifle.

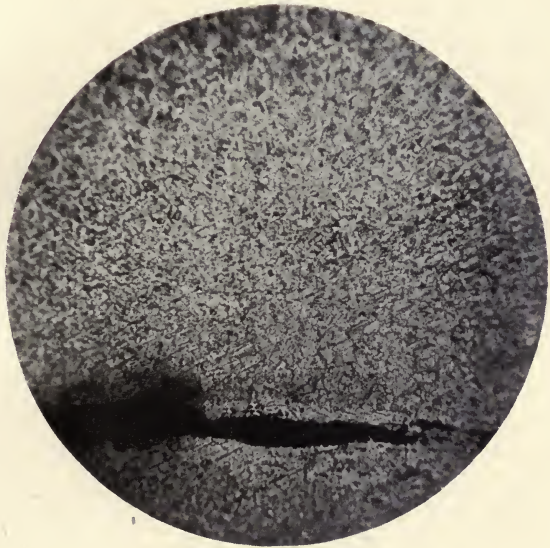
PHOTOGRAPH NO. 40. X50.

Crack and slag, with decarbonized area in 10-inch rifle.

Examination of sections in the vicinity of the crack showed many fine cracks, slag inclusions, and carbonless areas. The cracks led to slag, and where the slag was found there were also found decarbonized areas. Photograph No. 40 shows a crack ending in slag and surrounded by decarbonized iron. The course of the slag was quite irregular, as shown in photographs Nos. 41 and 42.

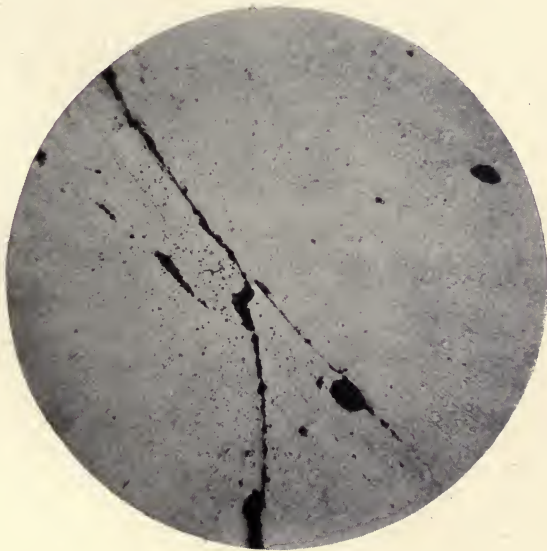
PHOTOGRAPH NO. 41. X50.

Slag in 10-inch rifle, unetched.

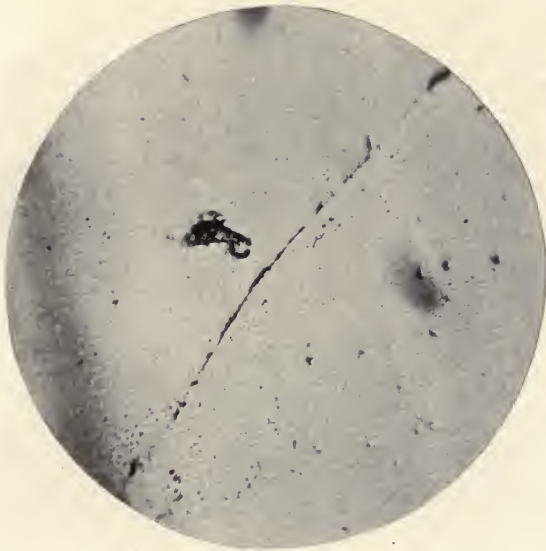
PHOTOGRAPH NO. 42. X50.
Slag in 10-inch rifle, unetched.

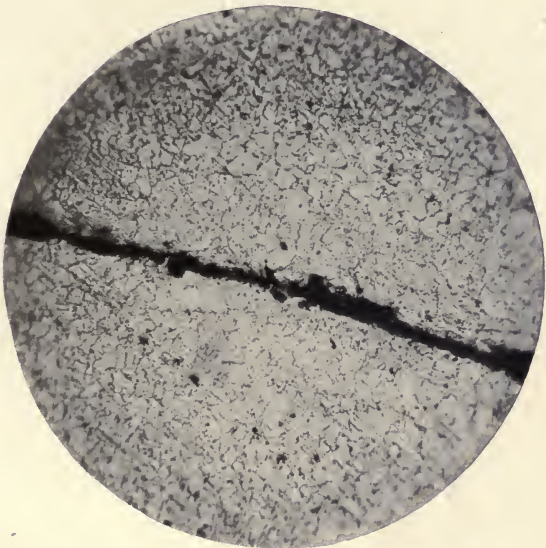
PHOTOGRAPH NO. 43. X50.
Slag and decarbonized area in 10-inch rifle.

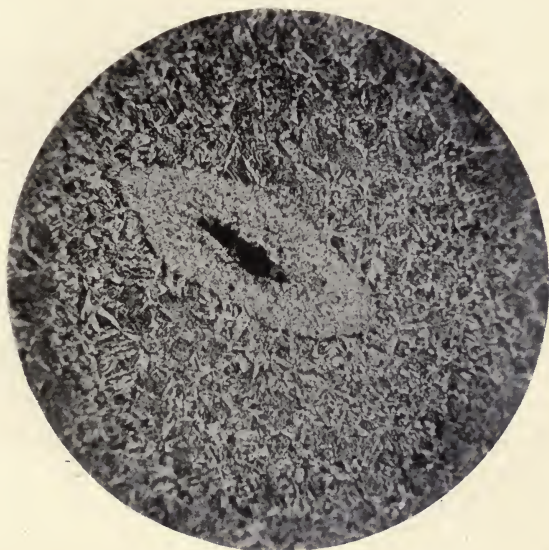
PHOTOGRAPH NO. 44. X50.

Island of slag in decarbonized area in 10-inch rifle.

That the slag originated and was folded into the metal during the process of forging rather than during the manufacture of the steel is indicated by the fact that it is strongly oxidizing in character. If it had originated at the time of making the steel, and had then burned out some of the carbon, there would still have been plenty of time for more carbon to have diffused back into these areas. It is found here, however, surrounded by free ferrite along the slag lines, as shown in photograph No. 43 and in photograph No. 44, in which is shown an isolated slag spot surrounded by free ferrite, and this in turn by the normal structure.

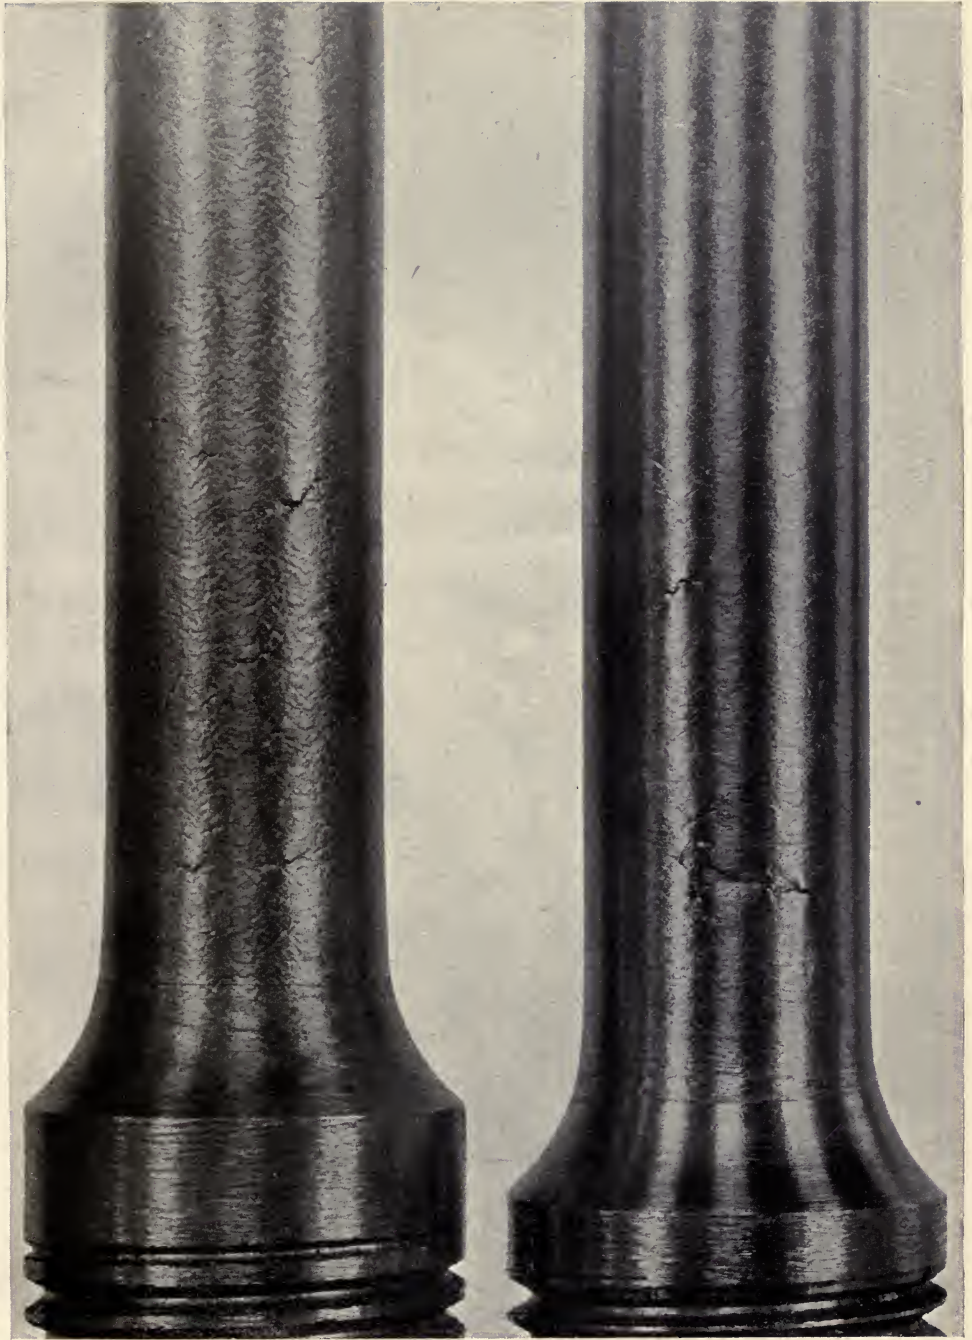
PHOTOGRAPH NO. 45.

Fourteen-inch gun lever test bar specimens showing incipient cracks.

In the fractured ends of the test pieces the metal shows decidedly bright spots, and these are due, it is believed, to the presence of the segregated ferrite. Further, it has been noticed that along the stem of the test pieces incipient cracks are developed, as shown in photograph No. 45. It is highly probable that these incipient fractures are developed in such areas as shown in photograph No. 47, which shows a large ferrite field at the edge of the specimen. It is possible that if the forces are transmitted equally throughout the test piece that such a portion would yield more readily where the carbon was lowest. The strength of such a spot would be approximately that of pure iron, or about 40,000 pounds per square inch, while the darker areas which contain more carbon would show considerably higher values. The presence of much slag in the ferrite areas would also increase the brittleness at this point, and would account for the low ductility in some specimens. Further examples of this form of segregation are shown in photographs Nos. 48 and 49.

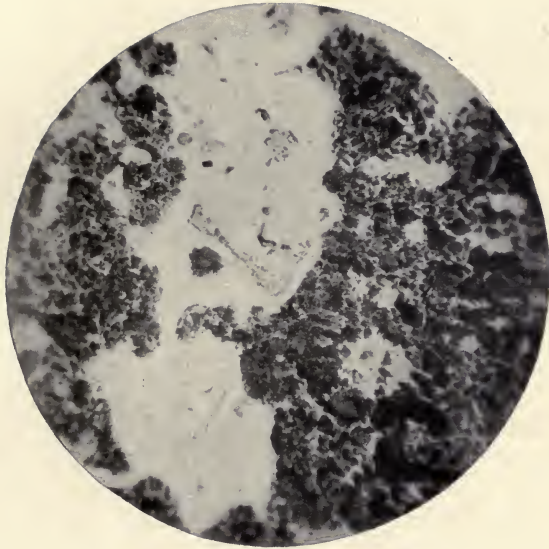
PHOTOGRAPH NO. 46. X50.

Fourteen-inch gun lever. Segregated ferrite (white) with slag inclosures.

This lever was made of cast steel and was broken during the test of the carriage. A microscopic examination revealed the structures shown in photographs Nos. 46 to 51, inclusive.

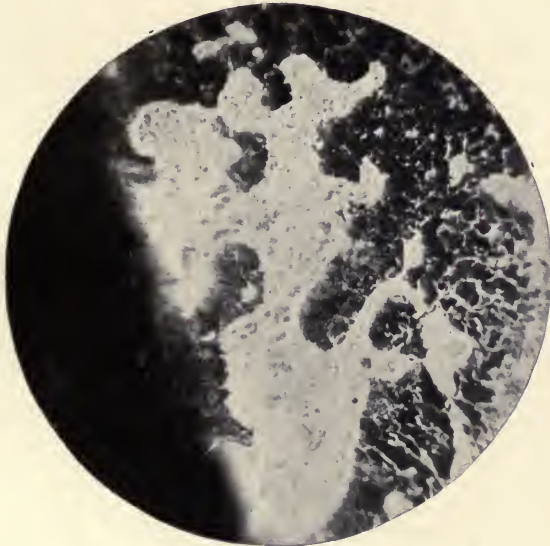
PHOTOGRAPH NO. 47. X50.

Fourteen-inch gun lever. Segregated ferrite on edge of test piece. Slag inclusions.

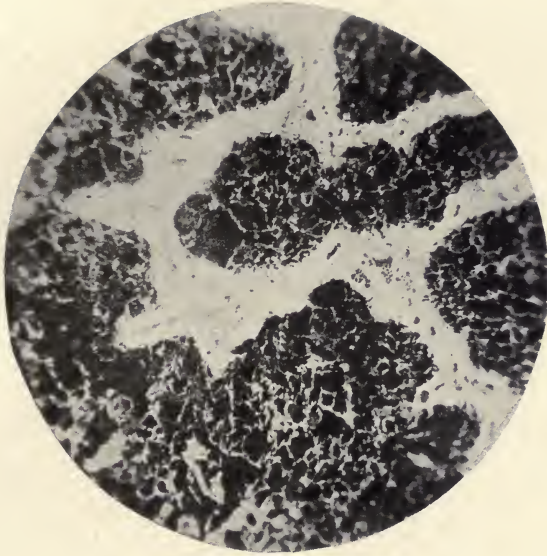
PHOTOGRAPH NO. 48. X50.

Fourteen-inch gun lever. Segregated ferrite (white) with slag inclusions.

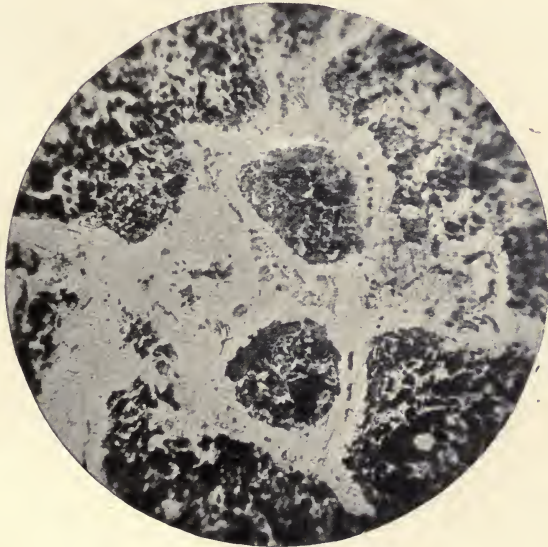
PHOTOGRAPH NO. 49. X50.

Fourteen-inch gun lever. Segregated ferrite with slag inclusions.

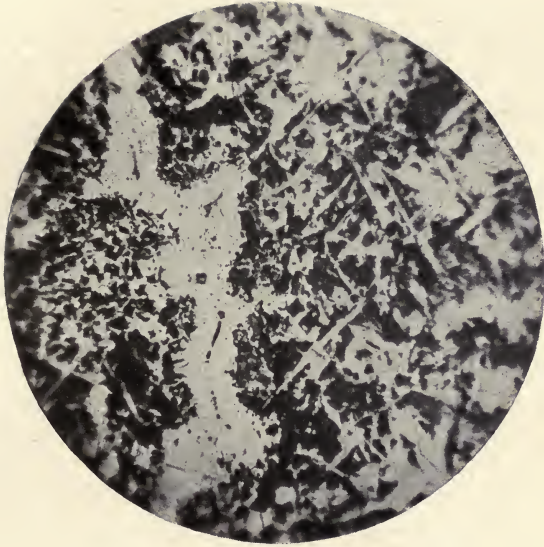
PHOTOGRAPH NO. 50. X50.

Fourteen-inch gun lever. Segregated ferrite and crystalline structure.

The metal has not been annealed in such a way as to remove the original crystallization which took place at the time of solidification. The crystalline structure is shown in photographs Nos. 50 and 51. Proper annealing should have completely wiped out all appearance of this kind. Evidence of this crystalline nature was found in all specimens examined, and it is highly

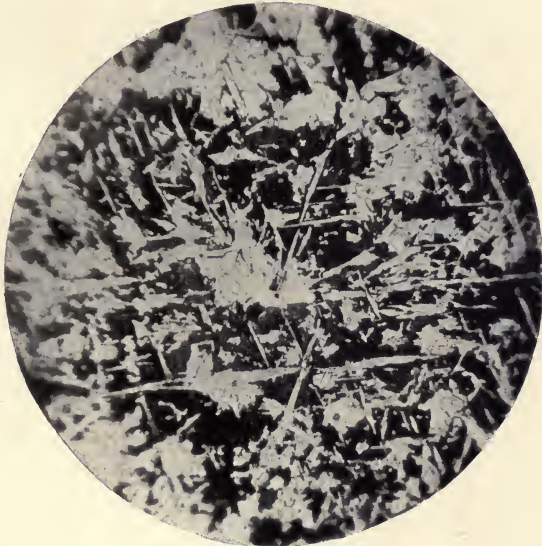
PHOTOGRAPH NO. 51. X50.

Fourteen-inch gun lever. Crystalline structure.
